**Flood Control Project Maintenance
Levee Inspections**
LMA District Cover Sheet
Spring 2017 Levee Inspection Results

Sutter Maintenance Yard Maintenance Area 0001

Spring 2017 Levee Inspection Results

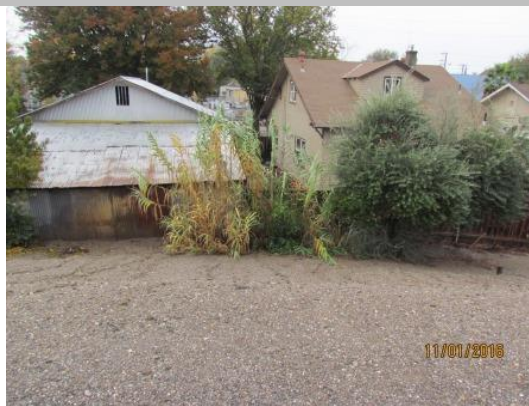
Photo 1 of 1 : SP_2017_MA0001_297_95_20170315_00028.jpg

View of the arundo along the landside toe.

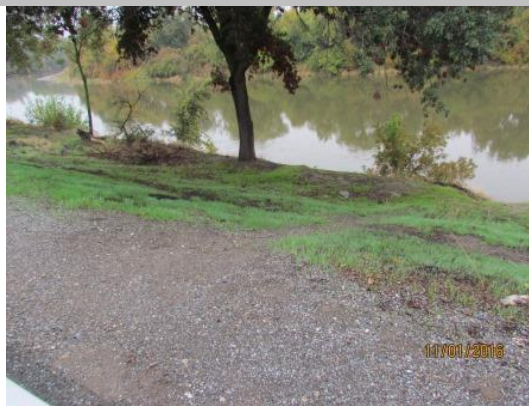
Photo 1 of 1 : SP_2017_MA0001_297_98_20170315_00030.jpg

LM Start	0.38	Rating **	M	Issue No.	98
LM End	0.38	Issue Type +	Ma	Location *	WS
Category	Earthen Levee			GPS Latitude/Longitude	
				Start	End
Item	Slope Stability			39.215878 °	39.215878 °
				-122.007278 °	-122.007278 °
DWR ID	DWR_MA0001_01_f_2016_98				
Comment Code					
S2 : Repair the levee slope damaged by foot traffic and prevent access where possible.					
Inspector Comment

View of the slope instability along the waterside slope.

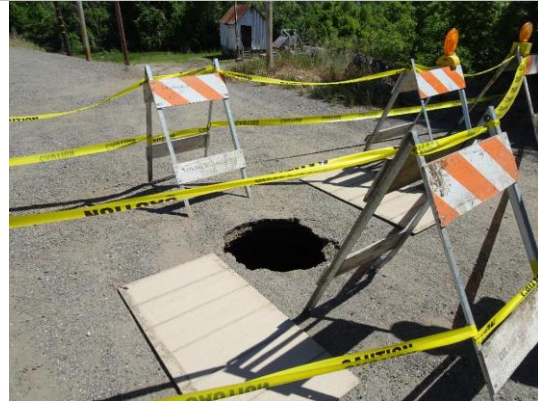
Photo 1 of 3 : UCIP_SP_2017_51822_77032.jpg

Repair Type: Urgent

View of sink hole on levee crown.

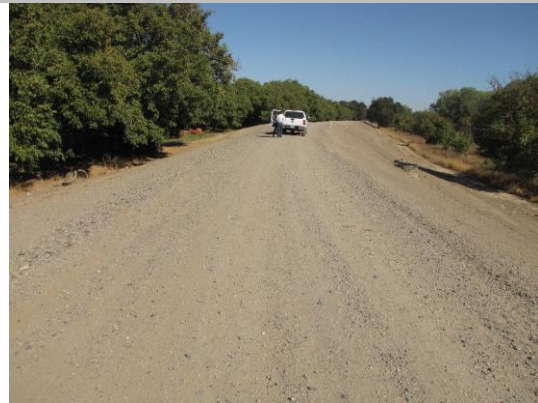
Photo 1 of 3 : UCIP_SP_2017_51852_70064.jpg

Comment Code					
Inspector Comment					
FS_ID:51852 DS_ID:16430 EP_NO: 9487 Repair Type: Non-Urgent Crossing Status: Found UCIP Comments: 5/3/2017 WS end still partially plugged. (DWR Sutter Yard- A Freitag)10/24/2016 Ws end is till partially plugged.(DWR Sutter Yard- A Freitag)4/25/2016 WS pipe end is still plugged with soil. Rest of the pipe appeared to be in good condition.4/20/2015 WS pipe end is plugged about 50% by soil.6/18/2014 Same as last inspection.12/17/2013 Same as last inspection.7/18/2013 WS pipe end has been reformed but is still clogged about 50% by sediment.10/18/2012 Remove dirt and debris in riser. Outlet deformed and blocked over 50%. Debris-round concrete section on landward side. This crossing was listed in the USACE Periodic Inspections as ID# USACE_CESPK_MA1C_2010_p_0116 for crossing outlet deformed and clogged with dirt. FIELD_STRUCT_DESC: 1 of 2: 36-inch corrugated metal drainage pipe through the levee, approximately 12-15 feet below the crown. Slide gates in corrugated metal pipe (CMP) riser located on the waterside (WS) slope. Pipe daylights on the landside (LS). (Automatic Board Order (ABO) issued as Permit No. 9487, 1974 - Jimeno Rancho) [Additional Reference(s): DWR Levee Log, 1992. USACE Sacramento O&M Manual 137, August 1955, (Station 103+18)]. FS Date: 5/19/2017 1:20:29 PM

Overview of levee crown and slopes looking upstream towards crossing.

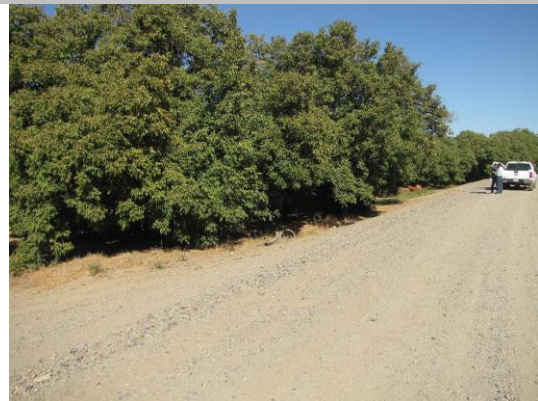
Photo 3 of 3 : UCIP_SP_2017_51852_70062.jpg

View of LS looking upstream at crossing.

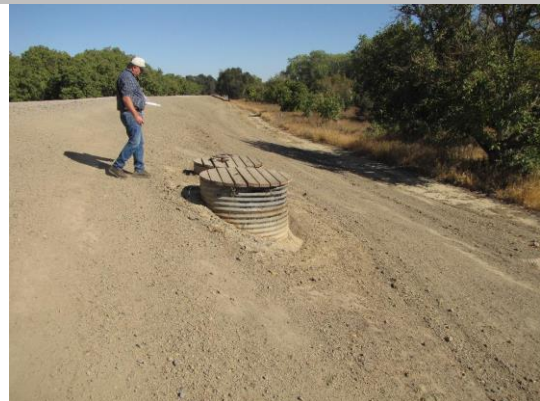
Photo 2 of 3 : UCIP_SP_2017_51853_70074.jpg

FS_ID:51853
DS_ID:17565
EP_NO: 9487
Repair Type: Non-Urgent
Crossing Status: Found
UCIP Comments: 5/3/2017 Ws end still partially plugged. (DWR Sutter Yard- A Freitag) 10/24/2016 Ws pipe end still plugged. (DWR Sutter Yard- A Freitag) 4/25/2016 WS pipe end still plugged with soil. rest of pipe appears in good condition. 4/20/2015 WS pipe end plugged about 50% by soil. 6/18/2014 Same as last inspection. 12/17/2013 Same as last inspection. 7/18/2013 WS pipe end has been reformed but is still partially blocked with dirt and debris. 10/18/2012 WS-remove dirt and debris in riser. Outlet deformed and blocked over 50%. Burrow activity near outlet on waterward slope. Debris around concrete section on landward side. This crossing was listed in the USACE Periodic Inspections as ID# USACE_CESPK_MA1C_2010_p_0116 for crossing outlet deformed and clogged with dirt.
FIELD_STRUCT_DESC: 2 of 2: 36-inch corrugated metal drainage pipe through the levee, approximately 12-15 feet below the crown. Slide gates in corrugated metal pipe (CMP) riser on the waterside (WS) slope. Pipe daylights on the landside (LS). (Automatic Board Order (ABO) issued as Permit No. 9487, 1974 - Jimeno Rancho) [Additional Reference(s): DWR Levee Log, 1992. USACE Sacramento O&M Manual 137, August 1955, (Station 103+18)].

View of CMP risers located on WS slope.

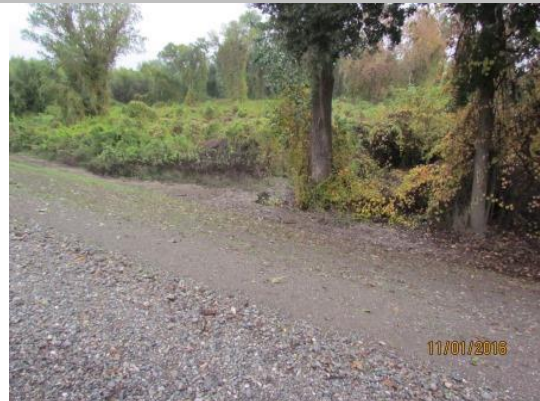
Photo 1 of 1 : SP_2017_MA0001_297_105_20170315_00036.jpg

View of an erosion site along the waterside berm.

E2 : Schedule repair of erosion site prior to the next inspection.

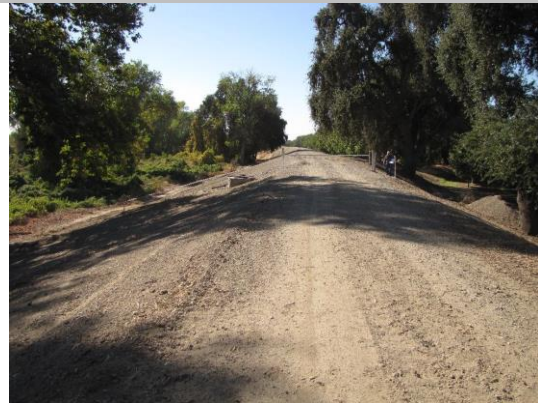
Photo 1 of 3 : UCIP_SP_2017_51854_70078.jpg

Comment Code					
Inspector Comment					
FS_ID:51854 DS_ID:16429 EP_NO: 9472 Repair Type: Non-Urgent Crossing Status: Found UCIP Comments: 5/3/2017 LS inlet partially plugged with soil. Some debris still present inside riser. (DWR Sutter Yard-AFreitag)10/24/2016 Debris still inside of riser.(DWR Sutter Yard-AFreitag)4/25/2016 Pipe still inside of riser and LS end plugged about 50% by soil.4/20/2015 Same as last inspection.6/18/2014 Same as last inspection.12/17/2013 Same as last inspection.7/18/2013 Same as last inspection.10/18/12 Remove debris from riser. Landward inlet is blocked by over 50%. This crossing was listed in the USACE Periodic Inspections as ID# USACE_CESPK_MA1C_2010_p_0128 for sediment build up at inlet (landward side) and debris inside riser. FIELD_STRUCT_DESC: 54-inch corrugated metal drainage pipe through the levee, approximately 12-15 feet below the crown. Slide gate in corrugated metal pipe (CMP) riser on the waterside (WS) slope. 48-inch CMP at landside (LS) slope. This crossing crosses the levee at an angle. (Automatic Board Order (ABO) issued as Permit No. 9472, 1974 - Ballard)) [Additional Reference(s): DWR Levee Log, 1992. USACE Sacramento O&M Manual 137, August 1955, (Station 120+00)]. FS Date: 5/19/2017 1:23:34 PM

View of levee crown looking downstream at crossing. CMP riser located on WS shoulder.

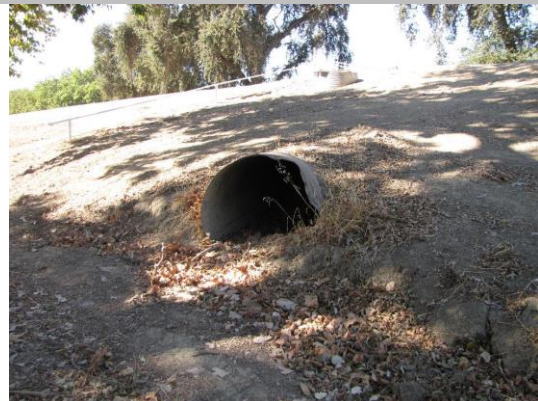
Photo 3 of 3 : UCIP_SP_2017_51854_70077.jpg

View of outlet located at WS toe.

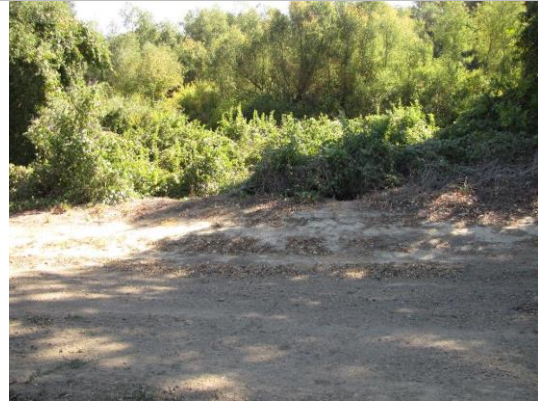
Photo 3 of 3 : UCIP_SP_2017_51855_70083.jpg

Item	DWR UCIP LMA Responsibility			39.236178 °	39.236178 °	
				-122.012812 °	-122.012812 °	
DWR ID						
Comment Code						
Inspector Comment						
FS_ID:51855 DS_ID:16428 EP_NO: 9467 Repair Type: Non-Urgent Crossing Status: Found UCIP Comments: 5/3/2017 Abanoned- needs to be done so properly. (DWR Sutter Yard- AFreitag)10/24/2016 Abandoned.(DWR Sutter Yard- AFreitag)4/25/2016 Abandoned crossing. Unable to locate any WS and LS pipe ends.4/20/2015 Same as last inspection.6/18/2014 Same as last inspection.12/17/2013 Same as last inspection.7/18/2013 Same as last inspection.10/18/2012 Only riser visible. Debris and sediment blocking gate. Gate inside riser is buried and non-functional. If crossing is abandoned, owner needs to properly abandon. This crossing was listed in the USACE Periodic Inspections as ID# USACE_CESPK_MA1C_2010_p_0132 no culvert through the levee is visible here. FIELD_STRUCT_DESC: *ABANDONED* 24-inch corrugated metal drainage pipe through the levee, approximately 12-15 feet below the crown. Slide gate in CM pipe riser on the waterside (WS) slope. No signs of inlet visible on the landside (LS). (Automatic Board Order (ABO) issued as Permit No. 9467, 1974 - Lovell E. Spurgeon) [Additional Reference(s): DWR Levee Log, 1992. USACE Sacramento O&M Manual 137, August 1955, (Station 120+60)]. FS Date: 5/19/2017 1:48:04 PM

Unable to locate WS outlet.

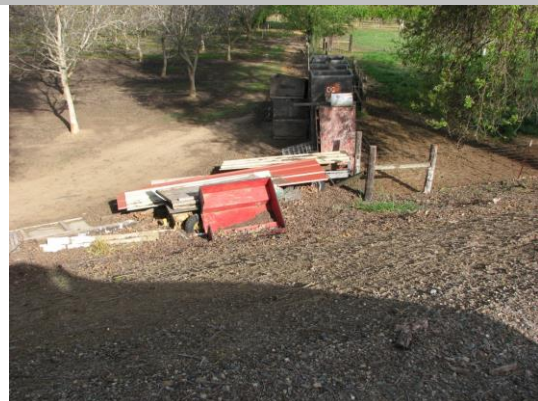
Photo 1 of 1 : SP_2017_MA0001_297_80_20170315_00018.jpg

LM Start	2.25	Rating **	M	Issue No.	80
LM End	2.25	Issue Type +	En	Location *	LS
Category	Earthen Levee			GPS Latitude/Longitude	
				Start	End
Item	Encroachments			39.236211 °	39.236211 °
				-122.012775 °	-122.012775 °
DWR ID	DWR_MA0001_01_s_2016_80				
Comment Code					
DE : Debris					
Inspector Comment					
Remove the metal roofing and other debris.

View of the equipment and debris obstructing access.

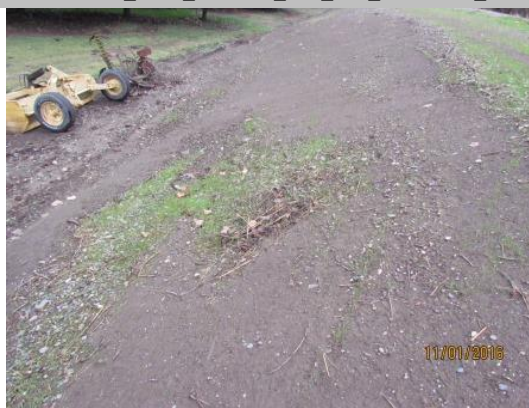
Photo 1 of 1 : SP_2017_MA0001_297_108_20170315_00040.jpg

LM Start	2.36	Rating **	M	Issue No.	108
LM End	2.36	Issue Type +	Ma	Location *	LS
Category	Earthen Levee			GPS Latitude/Longitude	
				Start	End
Item	Slope Stability			39.237628 °	39.237628 °
				-122.011967 °	-122.011967 °
DWR ID	DWR_MA0001_01_f_2016_108				
Comment Code					
S1 : Repair slope instability.					
Inspector Comment

View of the slope instability along the landside slope.

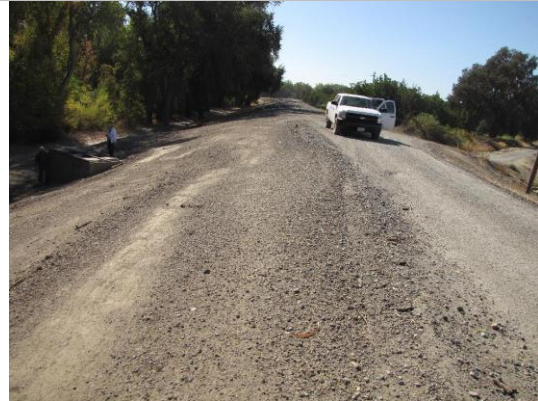
Photo 1 of 3 : UCIP_SP_2017_51856_70092.jpg

FS_ID:51856
DS_ID:16416
EP_NO: 9474
Repair Type: Non-Urgent
Crossing Status: Found
UCIP Comments: 5/3/2017 Appears abandoned- WS vault full of soil. Needs to be abandoned properly. (DWR Sutter Yard- AFreitag)10/24/2016 Appears to be abandoned. WS vault full of soil to help prevent water from flowing through during high water season.(DWR Sutter Yard- AFreitag)4/25/2016 Concrete box was filled with dirt to help prevent water from through during high water times.4/20/2015 Positive closure device is missing and water cannot be prevented from flowing through pipe during high water. 6/18/2014 Same as last inspection.12/17/2013 Same as last inspection.7/18/2013 Same as last inspection.10/18/12 During high water flow goes through levee. Missing positive closure device on waterward side. This structure appears abandoned-slide gates have been removed. Crossing needs to be properly abandoned. This crossing was listed in the USACE Periodic Inspection as ID# USACE_CESPK_MA1C_2010_p_0169 for concrete box partially filled with dirt.

Overview of levee crown looking downstream at crossing.

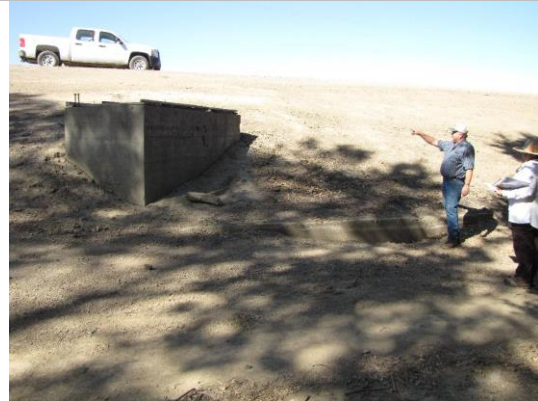
Photo 2 of 3 : UCIP_SP_2017_51856_70094.jpg

View of concrete distribution box and headwall located on WS.

FS_ID:51856
 DS_ID:16416
 EP_NO: 9474
 Repair Type: Non-Urgent
 Crossing Status: Found
 UCIP Comments: 5/3/2017 Appears abandoned- WS vault full of soil. Needs to be abandoned properly. (DWR Sutter Yard- AFreitag)10/24/2016 Appears to be abandoned. WS vault full of soil to help prevent water from flowing through during high water season.(DWR Sutter Yard- AFreitag)4/25/2016 Concrete box was filled with dirt to help prevent water from through during high water times.4/20/2015 Positive closure device is missing and water cannot be prevented from flowing through pipe during high water. 6/18/2014 Same as last inspection.12/17/2013 Same as last inspection.7/18/2013 Same as last inspection.10/18/12 During high water flow goes through levee. Missing positive closure device on waterward side. This structure appears abandoned-slide gates have been removed. Crossing needs to be properly abandoned. This crossing was listed in the USACE Periodic Inspection as ID# USACE_CESPK_MA1C_2010_p_0169 for concrete box partially filled with dirt.

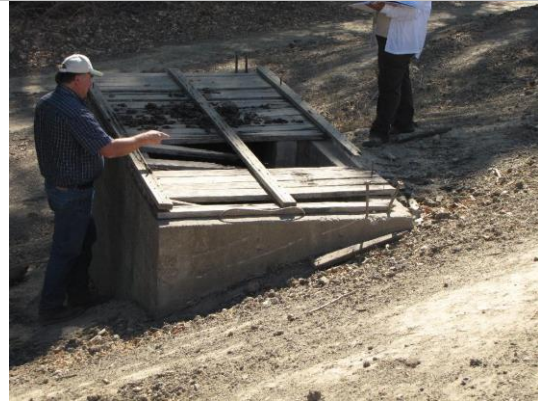
Photo 3 of 3 : UCIP_SP_2017_51856_70090.jpg

Concrete distribution box located on WS shoulder.

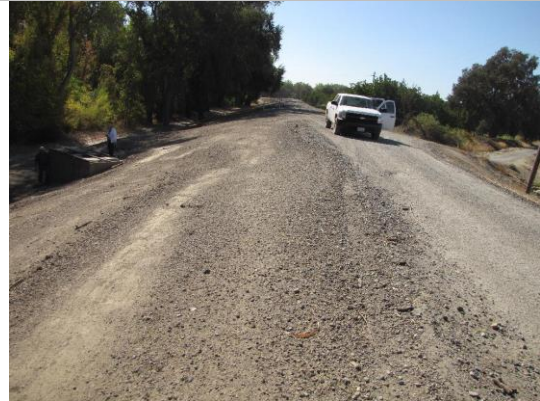
Photo 1 of 3 : UCIP_SP_2017_51857_70105.jpg

FS_ID:51857
DS_ID:17567
EP_NO: 9474
Repair Type: Non-Urgent
Crossing Status: Found
UCIP Comments: 5/3/2017 Appears abandoned- WS vault full of soil. Needs to be abandoned properly. (DWR Sutter Yard- A/Freitag)10/24/2016 Appears to be abandoned. WS vault full of soil to help prevent water from flowing through during high water season.(DWR Sutter Yard- A/Freitag)4/25/2016 Concrete box on WS was filled with soil to help prevent water from flowing through during times of high water.4/20/2015 Positive closure device is missing and water cannot be prevented from flowing through pipe during high water.6/18/2014 Same as last inspection.12/17/2013 Same as last inspection.7/18/2013 Same as last inspection.10/18/2015 During high water flow goes through levee. Missing positive closure device on waterward side. This structure appears abandoned-slide gates have been removed. Crossing needs to be properly abandoned. This crossing was listed in the USACE Periodic Inspection as ID# USACE_CESPK_MA1C_2010_p_0169 for concrete box partially filled with dirt.

Overview of levee crown looking downstream at crossing.

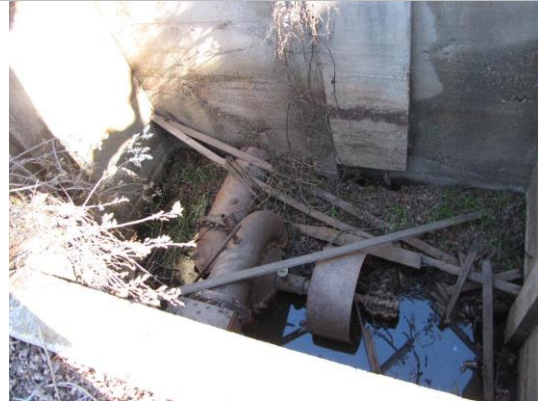
Photo 3 of 3 : UCIP_SP_2017_51861_70122.jpg

Debris inside concrete structure located on LS.

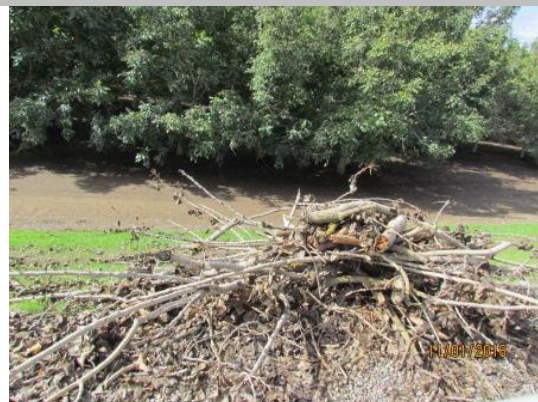
Photo 1 of 1 : SP_2017_MA0001_297_111_20170315_00043.jpg

View of the prunings along the landside toe.

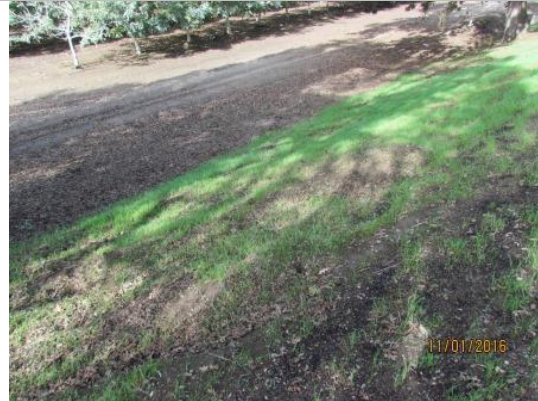
Photo 1 of 1 : SP_2017_MA0001_297_119_20170315_00048.jpg

View of the slope instability caused by vehicles along the landside slope.

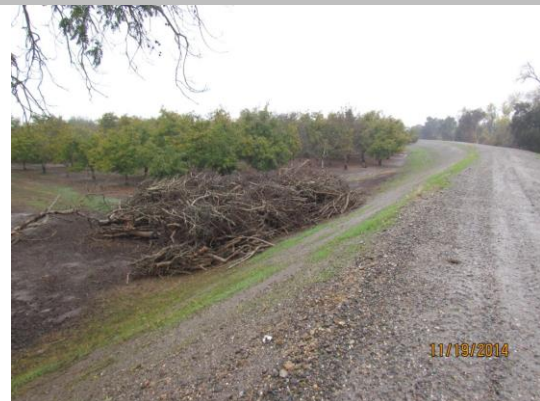
Photo 1 of 1 : SP_2017_MA0001_297_636_20170315_00064.jpg

View of the pruning along the landside toe.

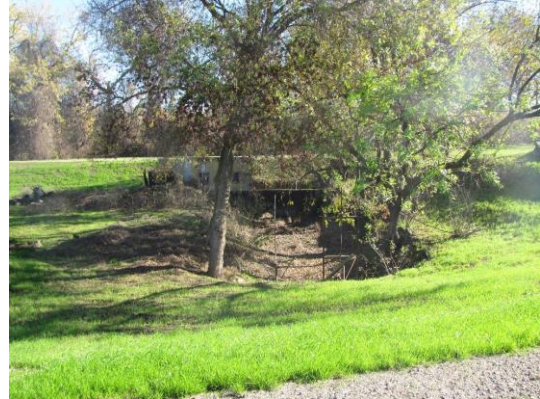
Photo 2 of 3 : UCIP_SP_2017_51889_70265.jpg

View of abandoned structure located on WS (inside ring levee).

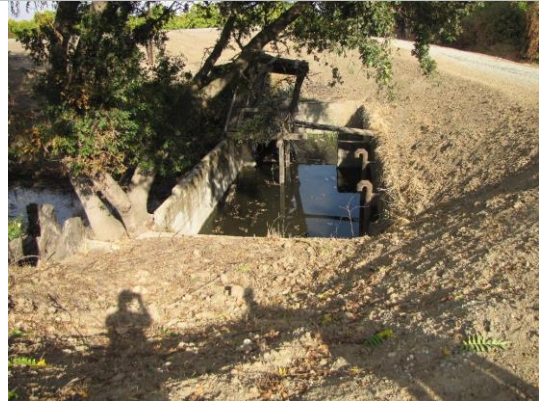
Photo 2 of 3 : UCIP_SP_2017_51891_70276.jpg

Abandoned structure (multiple headwalls and pump structure) located near the lower levee (ring levee).

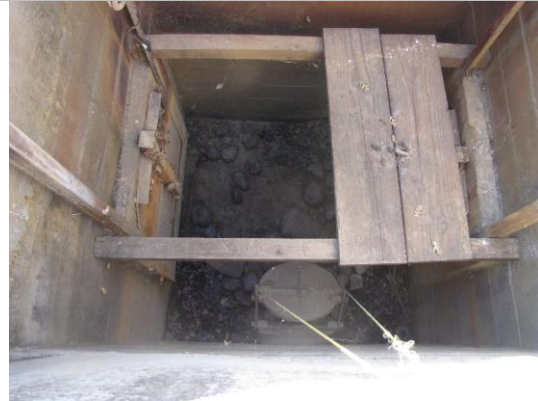
Photo 3 of 3 : UCIP_SP_2017_51912_70381.jpg

Repair Type: Urgent

Inside view of concrete distribution box located on LS toe.

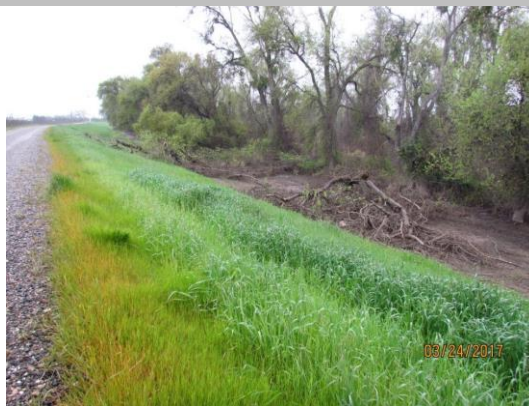
Photo 1 of 1 : SP_2017_MA0001_297_155_20170330_00187.jpg

View of the trees on the waterside slope and toe.
